Suppl Fig 1: Estimated reconstructed timeline of dredging, monitoring, and other coral reef disturbance events over approximately 112 weeks at the Port of Miami between late October 2014 and mid-December 2015. Black bars represent 10-week intervals.

Suppl. Fig 2: All photos from the location surveyed 200 m from the channel in the Inner Reef north, Linear Reef habitat. A-B) Illustration of 'halo' pattern of partial mortality originating from partial burial of the colony with sediment (B taken after diver had manually removed sediment by fanning). C-D) Additional examples of edge burial (C) and 'halo' pattern of partial mortality showing sediment interaction (D). E-F) Partially buried soft corals in an area of 'deep sediment over hardbottom' (DSOHB).

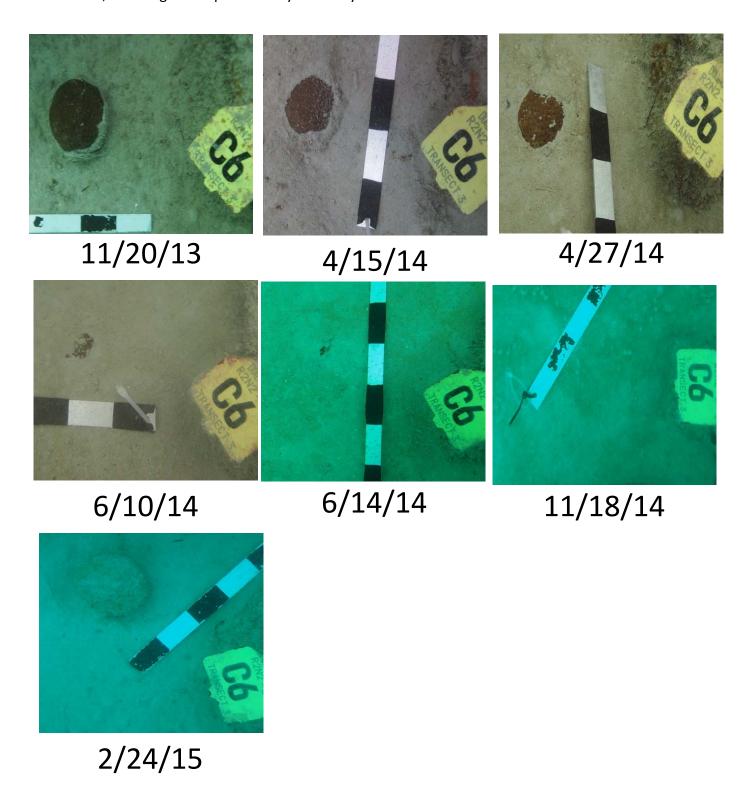
Suppl Fig 3A: Abbreviated time series photos illustrating common conditions. Channel-side Siderastrea siderea (R2N2 T3 C6) which was completely buried in sediment, apparently for several months, resulting in complete colony mortality

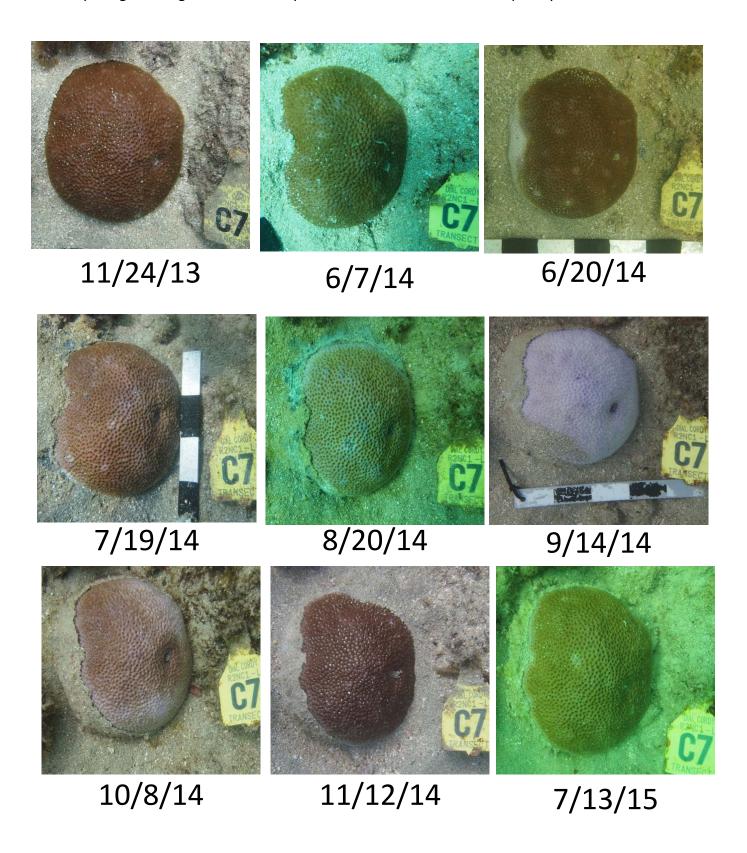
Suppl Fig 3C: Abbreviated time series photos illustrating common conditions. Reference colony of *Siderastrea siderea* (R2NC1 T1 C7) showing some apparent interaction with sediment along the colony margin throughout. This colony bleached in fall 2014 and subsequently recovered.
